Site Investigation into the Design of an Amusement Park in Riverside Park, Newcastle

Benedict Jones

21/03/2024

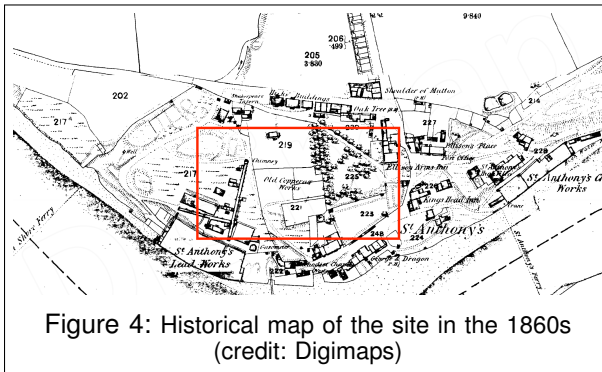
Figure 4: Historical map of the site in the 1860s (credit: Digimaps)

It is important to study the historical data of the site to gauge what activity may have taken place on in or around the area of the site. Figure 4 shows the outlay of the Riverside Park area in the 1860s; a copper works directly in the middle of the site as well as residential buildings (*Kings Head Inn*) around the site.

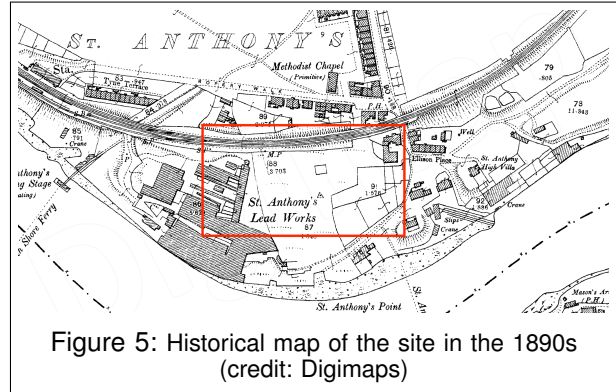
Figure 5: Historical map of the site in the 1890s (credit: Digimaps)

Figure 5 shows the area in the 1890s; the copper site has appeared to have been developed into a lead works and there are mentions of *cranes* alluding to the heavy industrial nature of the area at the time; notably there is a railway running above the site.

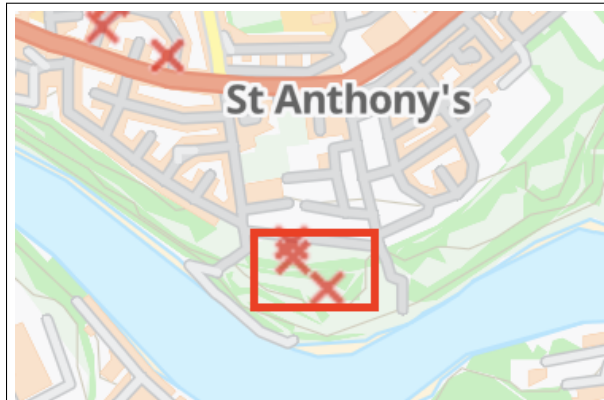
Figure 8: Recorded mining entry points - shown as red Xs (credit: The Coal Authority via the British Geological Survey; records from 2014))

There are three recorded mining entry points in the site (see Figure 8). They are deemed Development High Risk Areas [2].

- The presence of old mine shafts underscores the risk of subsidence in the locations established in Figure 8. The geological data in Figure 3 indicates a presence of Pennine Middle Coal Measures Formation, which further suggests historical coal mining activities in the area.

- **Mining Subsidence Risk:** The site's history includes coal mining activities, evidenced by recorded mining entry points. This historical mining legacy introduces the risk of ground subsidence, which could undermine structural stability. Addressing this requires detailed subsurface investigations to locate voids or weak spots that might collapse under the weight of new structures.

- Boreholes should be placed where historical maps indicate former industrial activity - i.e. the old copper and lead works and tar processing areas - to assess soil and groundwater contamination. Boreholes should also be located near the recorded mining entry points to evaluate subsidence risk. Figure 14 shows the proposed borehole locations. Two of them have been determined to assess the ground water and ground conditions in the proposed construction locations for the low rise buildings and ferris wheel. These boreholes should be drilled to depths of at least the proposed foundations to check for groundwater and bedrock. Depending on the size and design of the ferris wheel, this may be to a depth exceeding 10m (see proposed foundations by Wu on a large scale ferris wheel [8]). Previous borehole records from the bottom of the site area indicate that harder ground is located at depths of 5.5m-7m. This indicates boreholes may not need to exceed depths greater than this if this is also the case for the proposed borehole location. Another borehole should be taken on the water source at the bottom of the site and a borehole should be taken by the old tar works to check for chemical contamination - see section II-F.

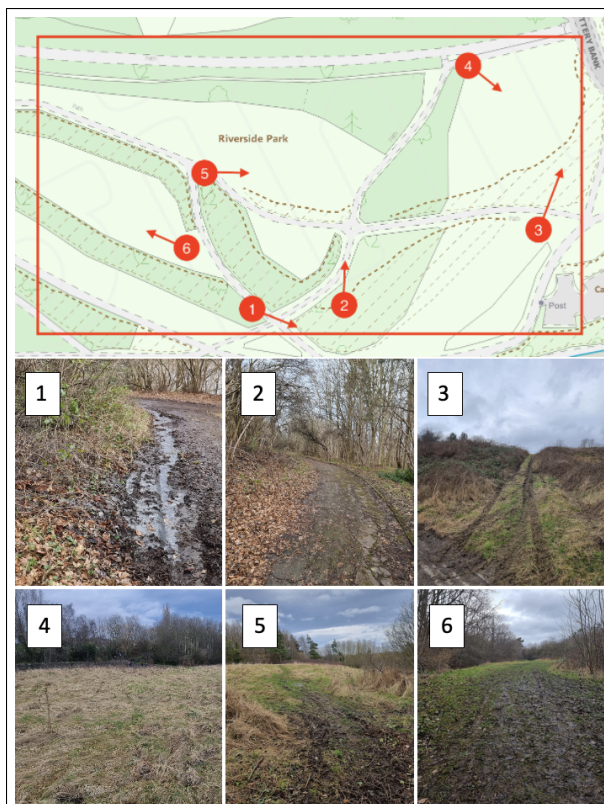
Figure 11: Images of interest within the site from the walkover survey, numbered and correspondingly located on the topographical map

The site was investigated during a walkover survey to compare the established desk study data with the existing site. Figure 11 shows six areas of interest observed during the walkover survey. Image 1 shows a water source on the edge of one of the paths; image 2 shows cracks on the concrete path and evidence of creeping of the ground above the path; image 3 shows a track which clearly has been previously used by vehicles to move between the upper and lower fields on the right hand side of the site; images 4,5 and 6 shows large grassy field areas, with evidence of water-logging and initially muddled ground.

- For soil compacting paths that appear to be creeping (see Figure 11, image 2), triaxial compression tests on collected soil samples should be taken to assess the soil's strength and stability to see if the paths should be reinforced or rerouted them to provide stable access for the construction of the ferris wheel and buildings. **The use of deep foundations for the ferris wheel, such as piles, is recommended.** Piles can bypass unstable or contaminated soil layers, providing stable support in deeper, more stable strata. **For the low-rise buildings, raft foundations could be a suitable choice,** especially if shallow soil contamination is confirmed. Raft foundations distribute the load over a large area and are suitable for soils with lower bearing capacities.
