Site Investigation into the Design of an Amusement Park in Riverside Park, Newcastle

Benedict Jones

21/03/2024

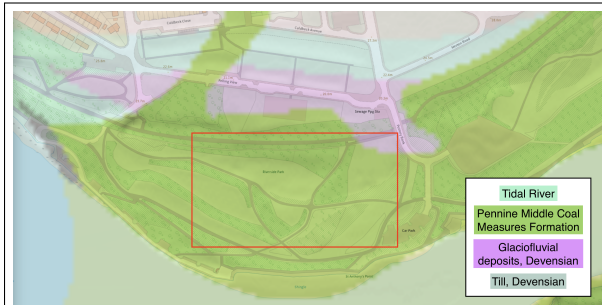
Figure 3: Geology of site using a coloured legend (credit: British Geology Survey)

Figure 3 shows the approximated geological formation of the land, via the BGS: British Geology Survey, with the site largely comprised of Pennine Middle Coal Measures Formation. According to the

BGS [1], this is a formation of mudstone, siltstone, sandstone and coal seams.

- The presence of old mine shafts underscores the risk of subsidence in the locations established in Figure 8. The geological data in Figure 3 indicates a presence of Pennine Middle Coal Measures Formation, which further suggests historical coal mining activities in the area.

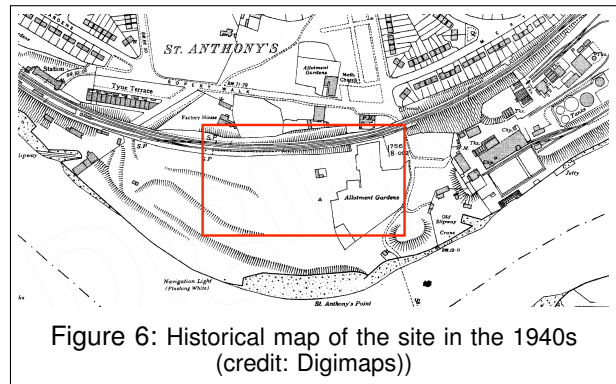
Figure 6: Historical map of the site in the 1940s (credit: Digimaps)

Figure 6 is of the area in the 1940s; the industrial developments of previous decades have appeared to disappear altogether from the site but there still seems to be some industrial buildings to the right of the site; the railway remains; more residential housing has been built above the site.

- Metal contaminants from Copper and Lead works in the late nineteenth century - i.e. Cu and Pb contamination may be found in the ground of the site.
- The industrial buildings to the right of the site seen in the 1940s and 1960s maps were in fact tar works [3]. This might insinuate contamination in the soil and groundwater of chemicals such as Polycyclic aromatic hydrocarbons (PAH) released by tar processing. A study [3] on the former tar works site shows the highest PAH concentration on the where the tarworks was seen in Figure 7 and some PAH contamination found in the river bed parallel with it.

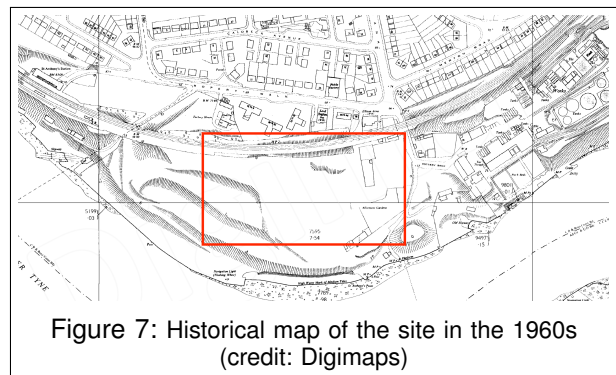
Figure 7: Historical map of the site in the 1960s (credit: Digimaps)

Figure 7 is the most recent *historical* map of the area; there is little change in the outlay or man-made development in or around the site from the 1940s map.

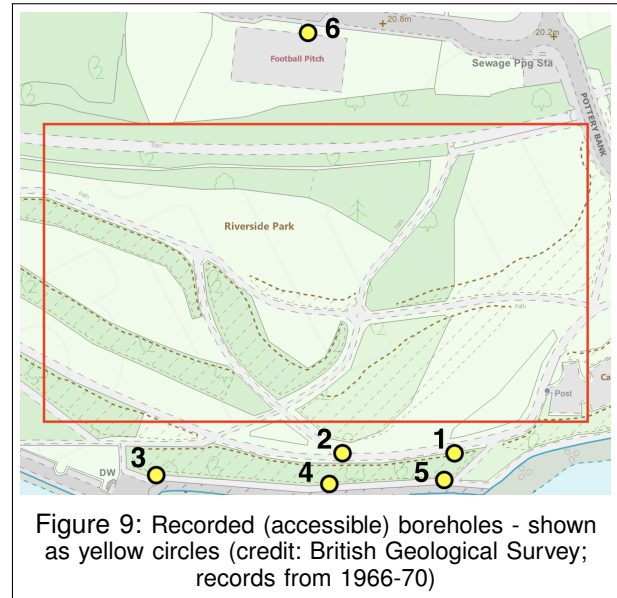
Figure 9: Recorded (accessible) boreholes - shown as yellow circles (credit: British Geological Survey; records from 1966-70)

Figure 9 show the locations, relative to the site, where there are readily available borehole records [4]&[5]. The boreholes below the site may prove as an accurate representation of the ground in the lower parts of the site especially. The site or area concerning these boreholes has not appeared to have had any major redevelopment since the 1940s when looking at section II-C.

- The borehole records from 1966-70 indicate that the ground is comprised of made ground/fill until it becomes very stiff silty clay and gravel at 5.5m to 7m below ground level [5]&[4]. No groundwater was encountered in any of the boreholes, which were drilled to depths of 10-12m. Looking at Figure 9, this may give an impression of the ground south of the site, but may also represent the site more generally. It should be acknowledged that these boreholes may not accurately represent the ground, despite no obvious redevelopments since before the 1960s.

- Boreholes should be placed where historical maps indicate former industrial activity - i.e. the old copper and lead works and tar processing areas - to assess soil and groundwater contamination. Boreholes should also be located near the recorded mining entry points to evaluate subsidence risk. Figure 14 shows the proposed borehole locations. Two of them have been determined to assess the ground water and ground conditions in the proposed construction locations for the low rise buildings and ferris wheel. These boreholes should be drilled to depths of at least the proposed foundations to check for groundwater and bedrock. Depending on the size and design of the ferris wheel, this may be to a depth exceeding 10m (see proposed foundations by Wu on a large scale ferris wheel [8]). Previous borehole records from the bottom of the site area indicate that harder ground is located at depths of 5.5m-7m. This indicates boreholes may not need to exceed depths greater than this if this is also the case for the proposed borehole location. Another borehole should be taken on the water source at the bottom of the site and a borehole should be taken by the old tar works to check for chemical contamination - see section II-F.

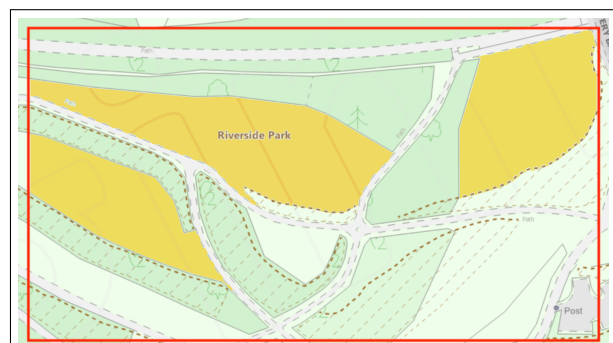
Figure 12: Suitable identified areas for building on (orange areas), subject to ground investigations

Figure 12 shows the proposed building locations for the ferris wheel and low rise buildings based on relatively flat, spacious and exposed ground.
